Jackson Hole Scientific Investigations, Inc.

July 12, 2014

Re: State of Wyoming v Knospler
JHSI 14-004-0206

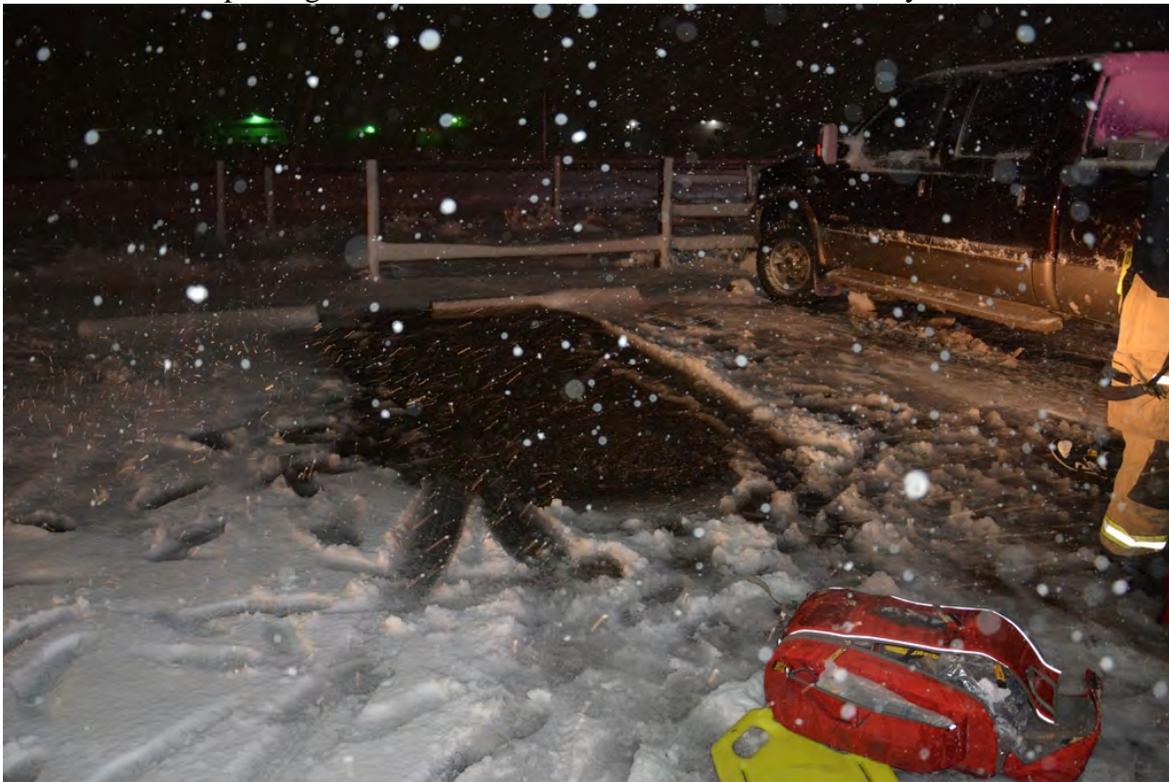
There is substantial scene evidence that Knospler had started to drive away before the final confrontation with Baldwin. On the photo below, we see the Cavalier had been parked so that its back end was at the parking block and the area under the car was relatively free of snow.

Note the presence of the tire marks leading away from the parking spot as well as the location of Baldwin's body (foot) on the right side of the photo. In addition, there was a bullet strike on the bed of the Ford pickup parked up against the parking block and adjacent to the Cavalier's parking space.

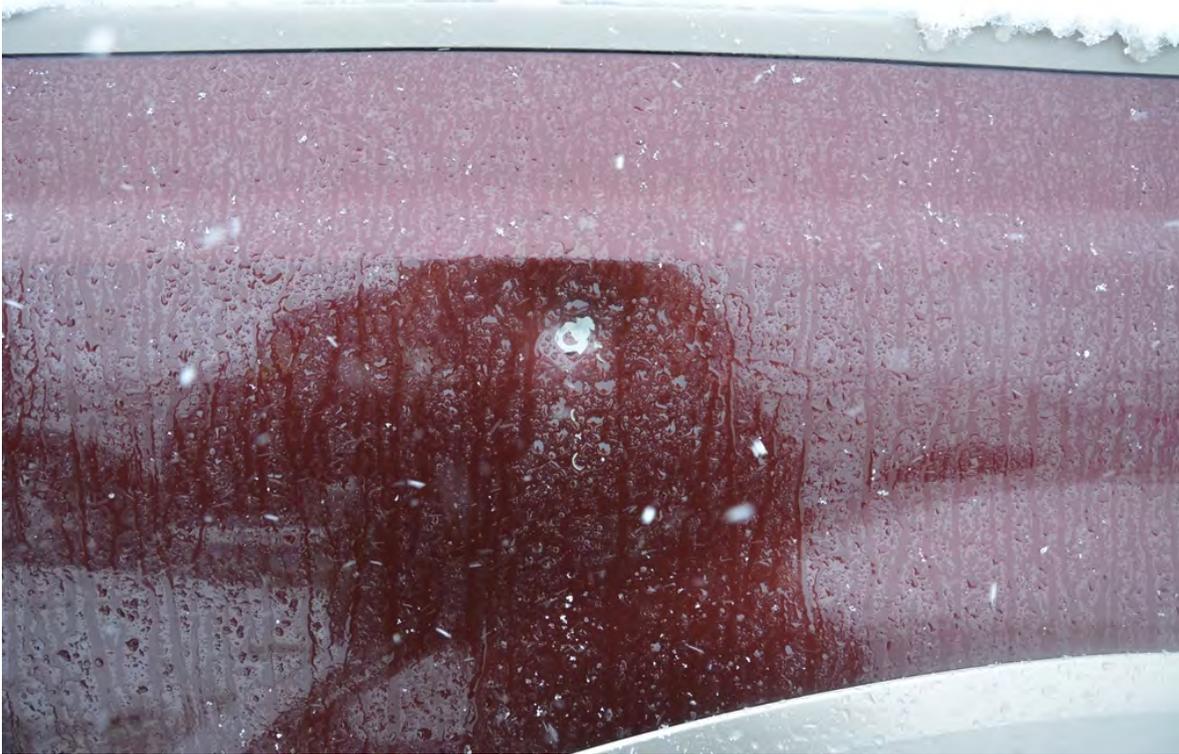
This photo of the bullet strike in the bed side of the Ford pickup shows a bullet mark with a W/L ratio of about 0.95 or so. This corresponds to a strike angle of about 72 degrees. If the shot came from the vicinity of the driver's side window, this is also an indicator that the Cavalier had moved ahead as the bullet strike on the Ford would have been at about a 35 degree angle with a W/D ratio of about 0.57. The 3D drawing below by Trooper Sawdon illustrates this.

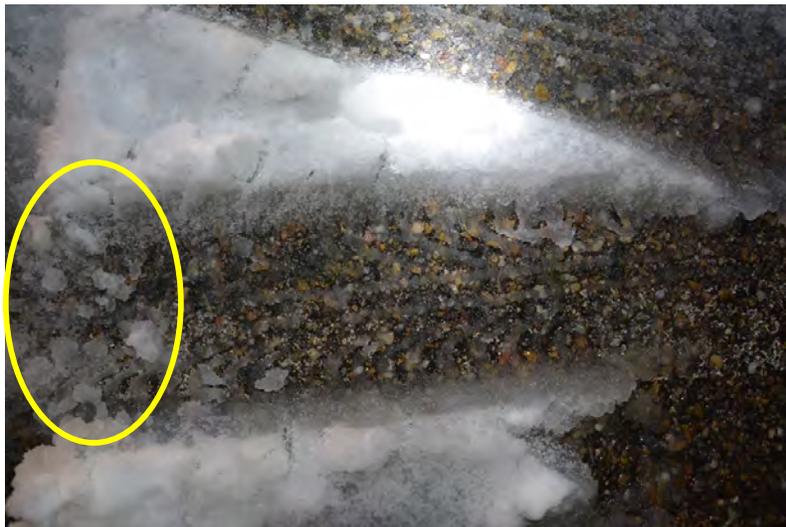
In this photo, note both the area within the oval and the area to the right of the oval. This is most likely the passenger side front tire of the Cavalier, which is a front wheel drive vehicle. To the right of the oval we see a tire print in the snow surface, consistent with a tire that is rolling and still has some traction. Within the oval, there is snow deposited across the tire print, obscuring it. This is consistent with a tire that has lost traction on this slick surface and is spinning, depositing snow to its rear. This is evidence that the Cavalier, while still trying to go forward, had lost the tractive ability to do so.

In my opinion, based on the evidence I have seen, a reasonable scenario is that Knospler tried to drive away from the confrontation with Baldwin, but was not able to do so because he lost traction on the snowy surface in front of his vehicle as he accelerated away from the parking space.

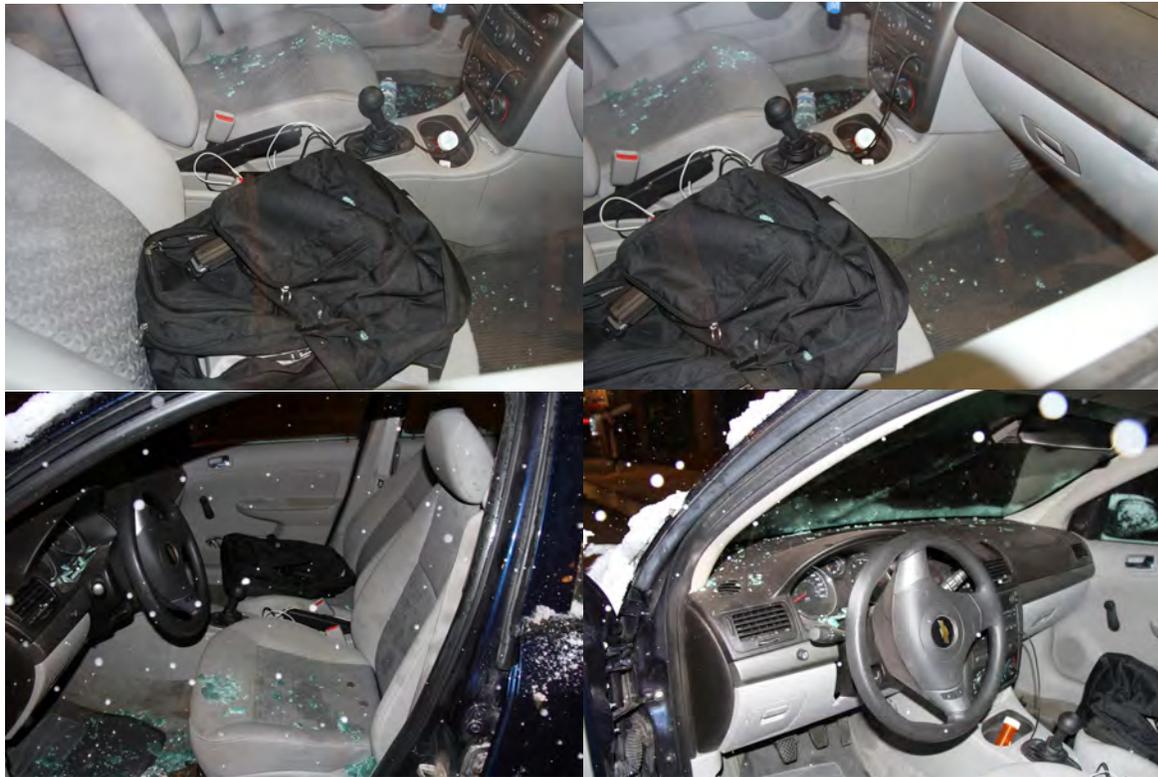
The first evidence I will address is the distribution of the broken tempered glass from the driver's side window. There was broken glass both outside the Cavalier near the driver's door and also broken glass distributed throughout the front of the passenger compartment, as shown in the photos below.

The only way for the glass to be scattered within the vehicle with such a large scattering distribution is for a force applied to the glass to accelerate it in the direction of the interior of the car. This observation comes from Newton's Second Law, which is commonly written as $\mathbf{F}=\mathbf{ma}$. Notice in this equation that both the \mathbf{F} and \mathbf{a} variables are bolded. This tells us that Newton's Second law is a vector equation. Simply put, this tells us that the acceleration of any object is in the direction of the applied, external, unbalanced force. The only way for glass to be scattered throughout the passenger compartment as the photos illustrate is for the breaking force to be directed into the passenger compartment.

A 230 grain .45 caliber FMJRN bullet fired from inside the passenger compartment would be directing all of its impact force toward the outside of the vehicle. The transit time through the glass for this bullet at a muzzle velocity of about 800 feet per second would be on the order of 0.00006 to .00007 seconds. In addition, the applied force, while relatively large, is concentrated in a very small area. Because of the inertial properties of the glass that would be penetrated, there is only a small amount of glass that could have been projected outward during the transit of the bullet. Absent other forces, it is not unusual for the bulk of a tempered glass window that has been penetrated by a bullet to remain essentially in place except for the region immediately in contact with the bullet. I recommended this shooting test be done in this case, but it has not been carried out as of this writing. If the glass collapsed on the driver's side window after the passage of the bullet, some would likely have fallen to the outside of the Cavalier, with the remainder of the glass being inside the passenger compartment very near the driver's side. It would not have been scattered so widely throughout the passenger compartment.

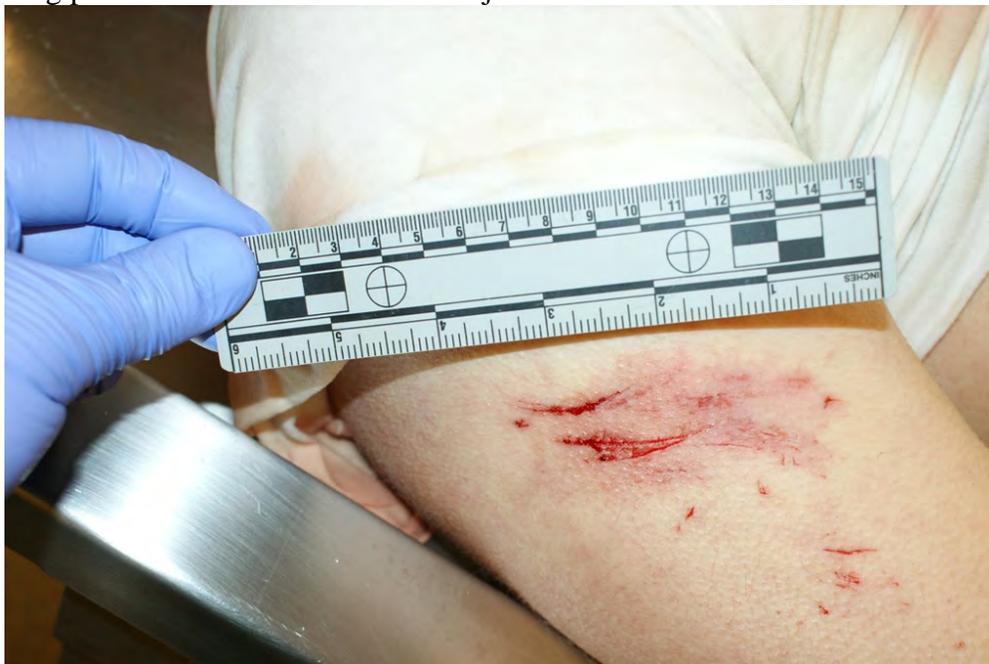
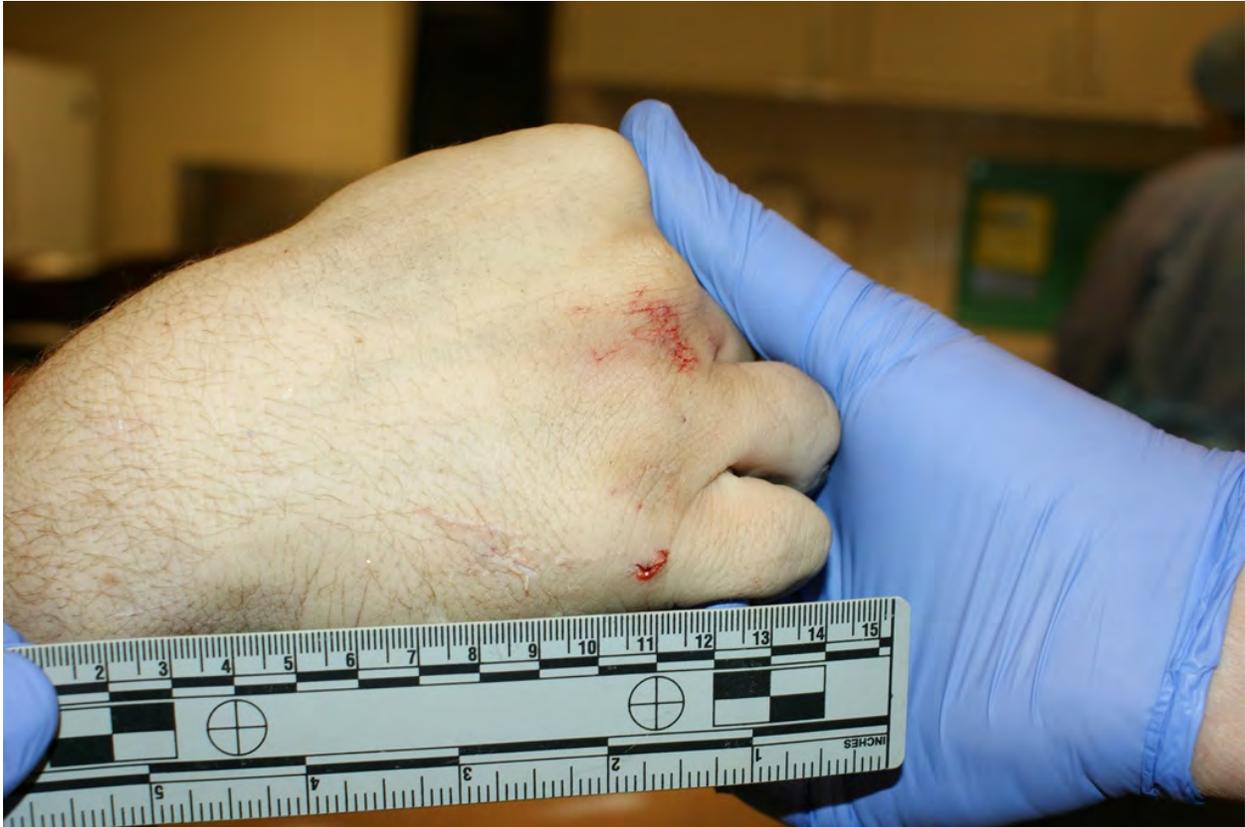
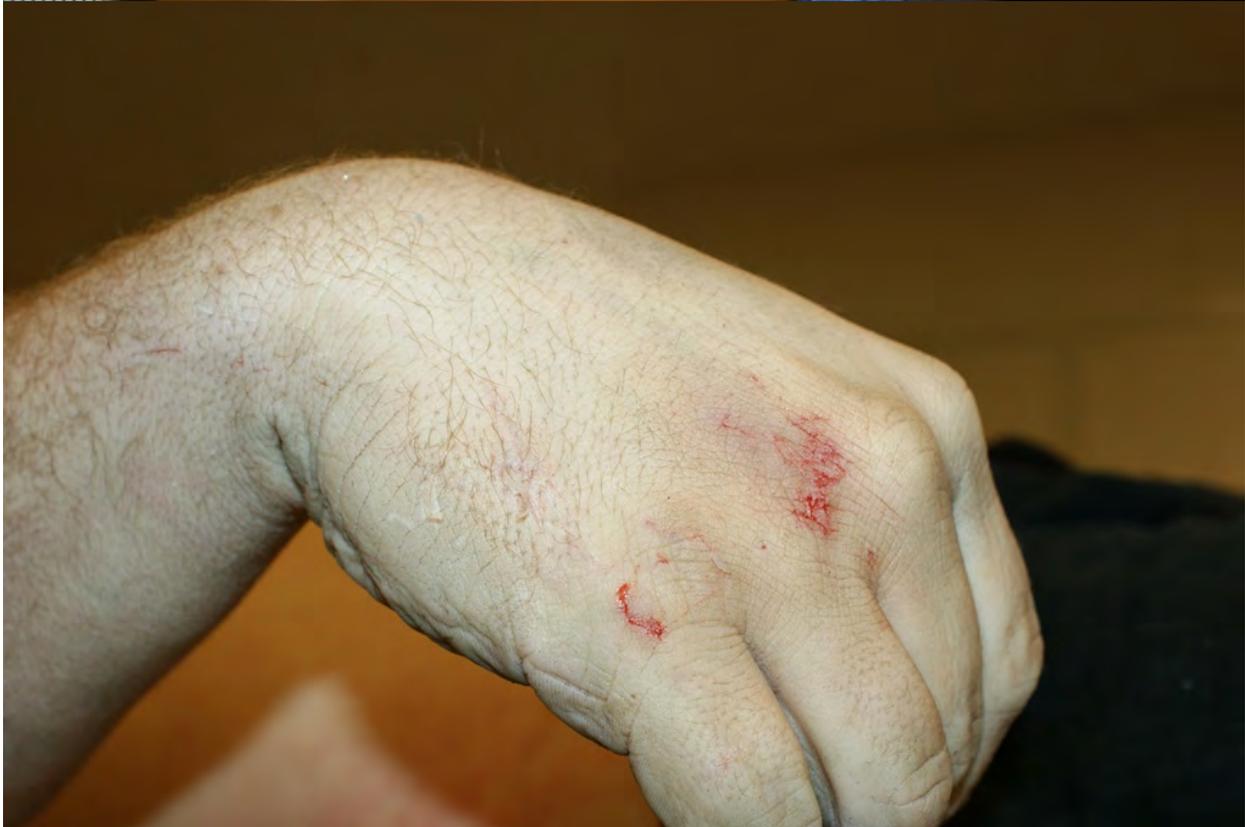
The following photos illustrate the described injuries on the arm and hand:

These injuries are described as both lacerations and “dicing-type” injuries by Dr. Carver. Dicing injuries are common in traffic crashes when a vehicle occupant comes in contact with tempered glass, causing it to fracture. Tempered glass breaks into many small pieces upon fracturing; causing these dicing injuries to the body part that causes the fracture.

These injuries to Baldwin are consistent with him punching out the window and subsequently getting far enough onto the passenger compartment of the vehicle to receive the dicing and lacerations on his upper right arm near the shoulder. This also accounts for a force coming into the passenger compartment on the driver’s side and causing a wide dispersion of glass within the passenger compartment.

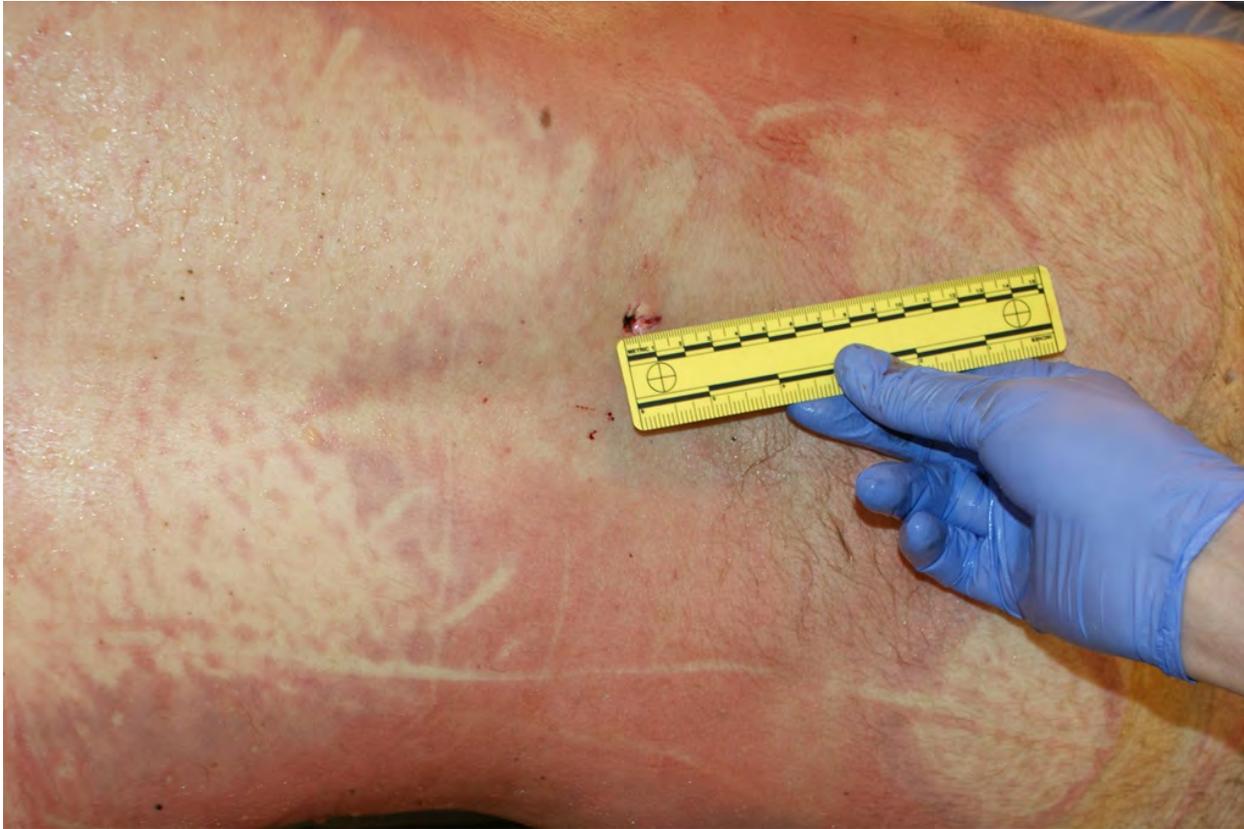
The exit wound is on the back, 26 inches down from the vertex of the head and 1.5 inches to the right of the posterior midline. The wound is described as a 1.5 cm stellate laceration with no soot, searing, or stippling from gunpowder particles. The next photo illustrates this wound.

The evidence from the autopsy suggests a relatively straight bullet path through Baldwin's torso. This may be expected from a FMJRN projectile at relatively low velocity such as one would see from a 1911 style .45 semi-auto pistol. Since there is no evidence that Knospler ever got out of his car to shoot Baldwin, this means that Baldwin would have to be leaning down by the driver's side window, facing the window in order for the entrance and exit wounds to be as described.

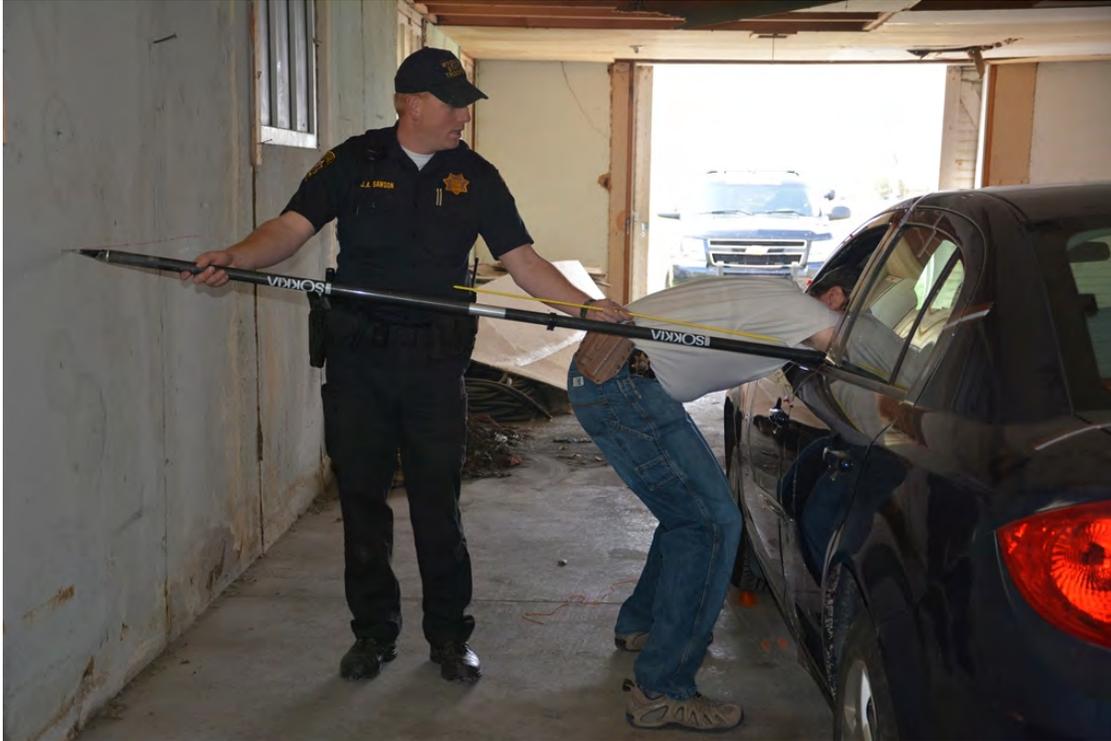
The photos beginning on the next page illustrate reconstruction that would account for both the bullet path and the glass dispersion in the passenger compartment. These place Baldwin within the passenger compartment.

The above photo places Baldwin partially in the passenger compartment. This accounts for the bullet trajectory and the injury noted to Baldwin's upper right arm from the broken tempered glass. It also accounts for the glass dispersion in the passenger compartment if Baldwin had punched out the window, thus injuring his right hand as noted in the autopsy report. The same comments hold for the photo below.

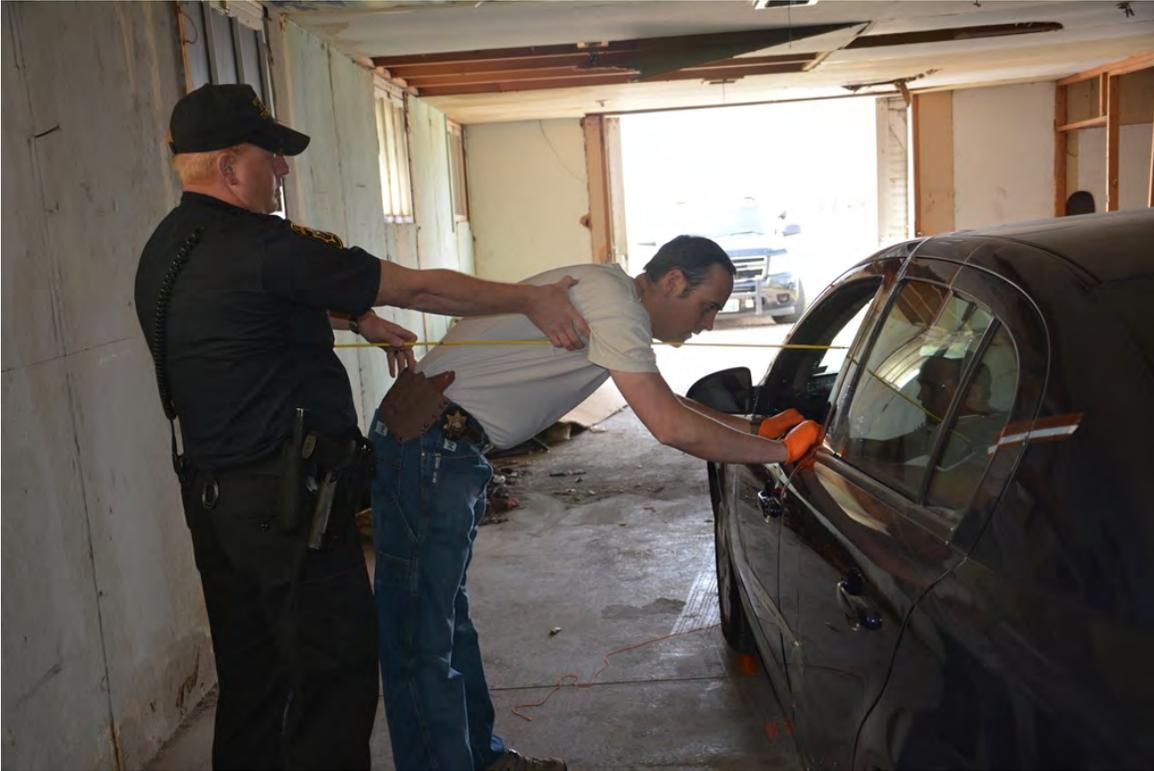
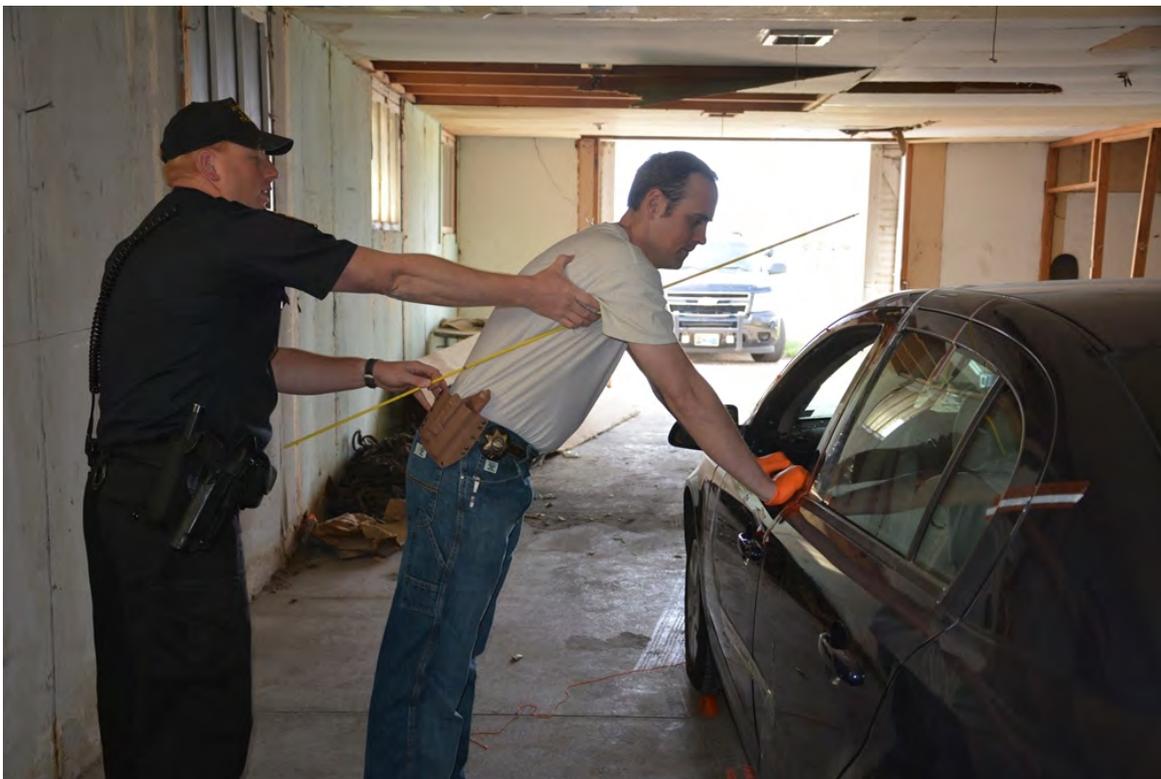
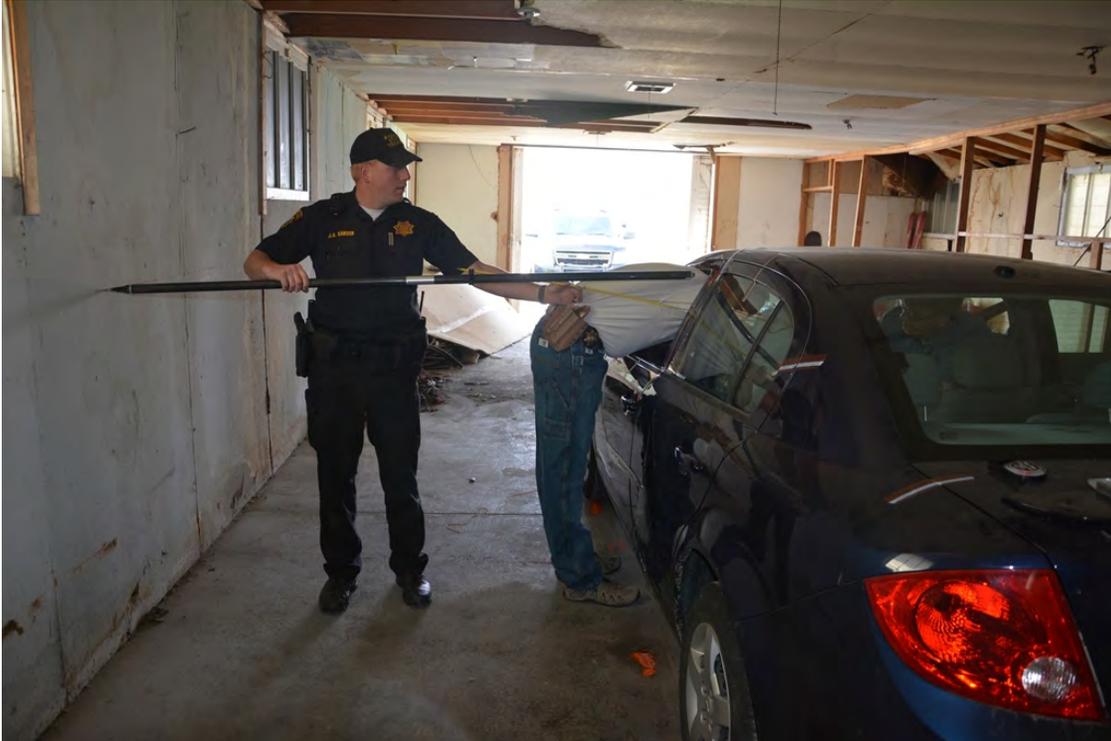
The following photos from the reconstruction of possible scenarios either show an impact on the Ford pickup inconsistent with the scene measurements or fail to account for the glass dispersion and injuries to Baldwin's right hand and upper arm.

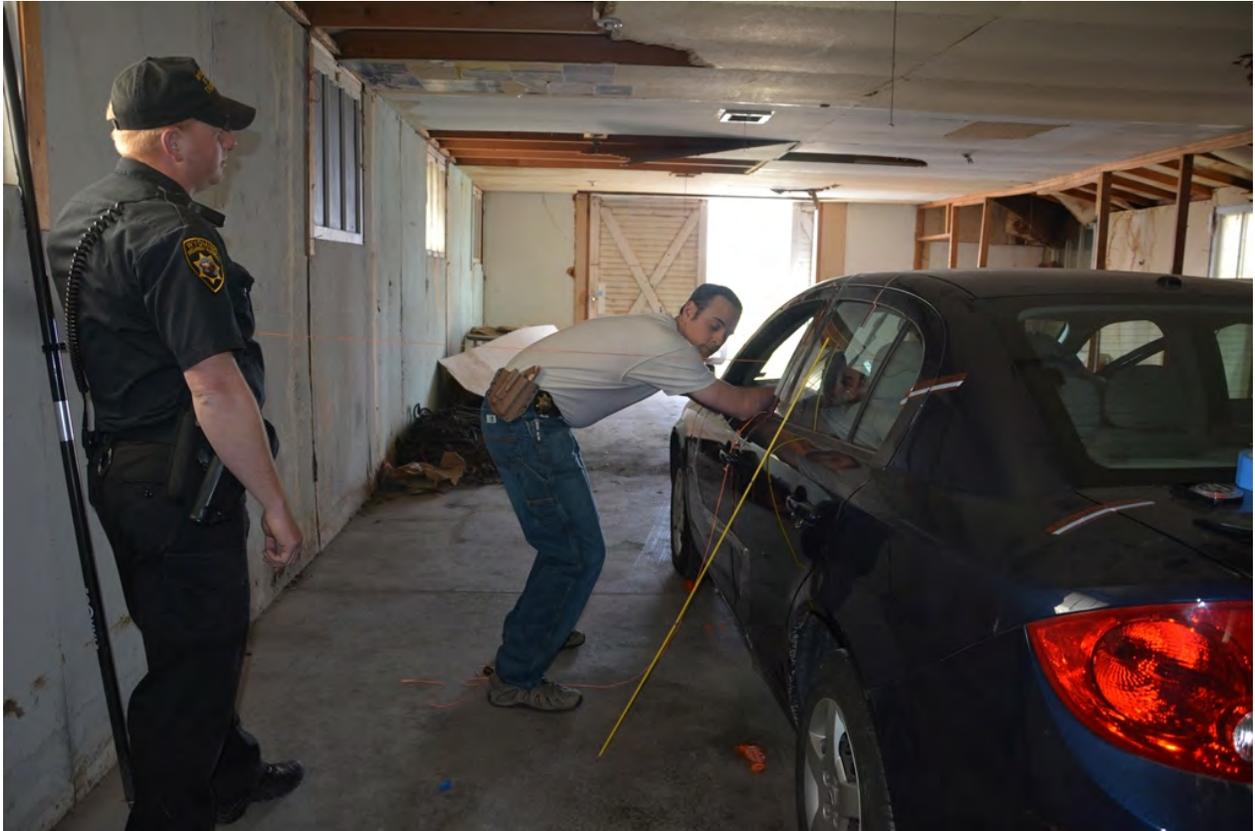
The photo on the next page shows a possible scenario that would account for the injuries to Baldwin's hand and arm, the dispersion of the glass inside the passenger compartment, the glass on the outside of the driver's door on the ground and the bullet path through Baldwin's torso. One must keep in mind this was a dynamic event being recreated by means of still photographs.

If Baldwin punched out the driver's side window and entered the Cavalier far enough to injure his right upper arm and hand from the broken tempered glass, then the glass dispersion issue inside the passenger compartment is satisfied as are Baldwin's injuries. If Baldwin then began to extract himself from the passenger compartment at about the same time that Knospler produced his .45 and shot Baldwin, then the act of pulling back from inside the passenger compartment would pull some of the broken tempered glass to the outside of the Cavalier to land on the ground near the driver's door. In addition, the bullet trajectory through Baldwin and its subsequent impact on the Ford pickup adjacent to the Cavalier is consistent with the evidence we see in this case.

In my opinion, Baldwin punched out the driver's side glass of the Cavalier, injuring his right hand and entering the passenger compartment far enough to get dicing injuries from the broken tempered glass on his right upper arm. He may have then started to extract himself from the passenger compartment, dragging some of the broken tempered glass with him. Somewhere in this extraction, he was shot by Knospler, thus resulting in a gunshot wound of indeterminate range.
